Intel386™ EX Embedded Processor

Specification Update

August 2004

Order Number: 272873-011

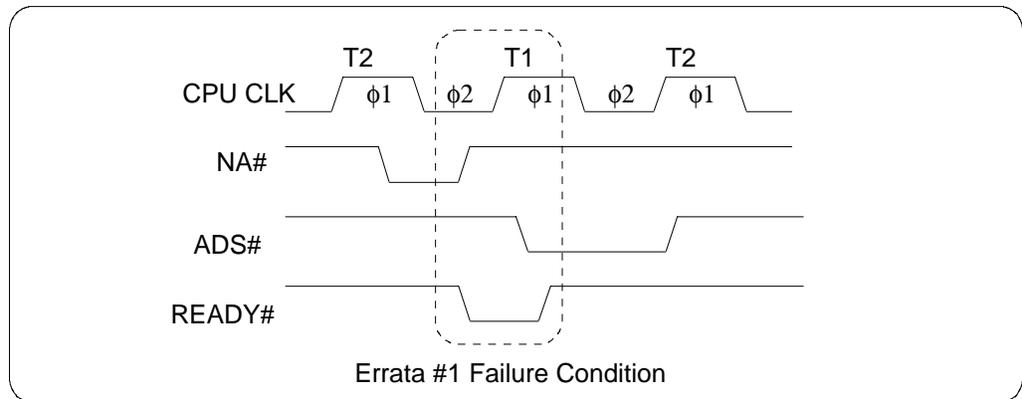
1. Watchdog Timer (WDT) Bus Monitor Failure During Bus Pipeline Operation

Problem: The errata applies to the WDT unit when using the Bus Monitor Mode and Bus Pipeline operation. If a pipelined bus cycle is requested at the same time the current bus cycle is completed, the WDT down counter is not reloaded or stopped. This condition means that the WDT could time-out and erroneously report a system failure. The waveform below shows the errant condition.

The errata condition is caused by the system generating READY# immediately after NA# has been requested, and a T1 cycle is generated (rather than a T2P cycle). Essentially, the system is requesting a pipelined access, but does not need it because READY# has been returned. Such a condition is not typically expected when using the pipeline feature.

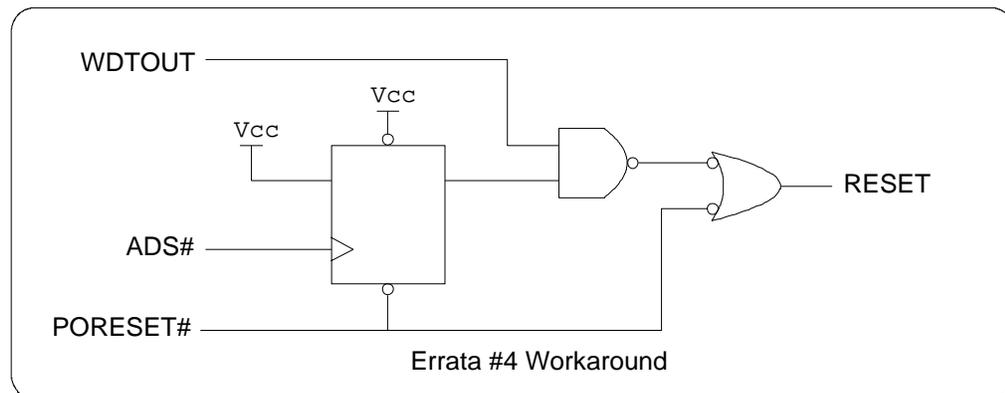
Implication: This errata only applies to a system design that uses the WDTOUT signal to generate a device reset. The WDT will time out and reset the device before the CPU self-test can complete.

Workaround: The WDTOUT signal cannot be directly tied to the RESET input during self-test since there is no mechanism to increase the default value loaded into the WDT counter. The circuit shown below can be used to block WDTOUT until the first ADS# is generated. The signal PORESET# is a power-on reset signal generated by the system. WDTOUT is an output of the Intel386 EX processor, and RESET is an input to the processor. Please note that the circuit below has not been tested in a real design and is provided as an example only.

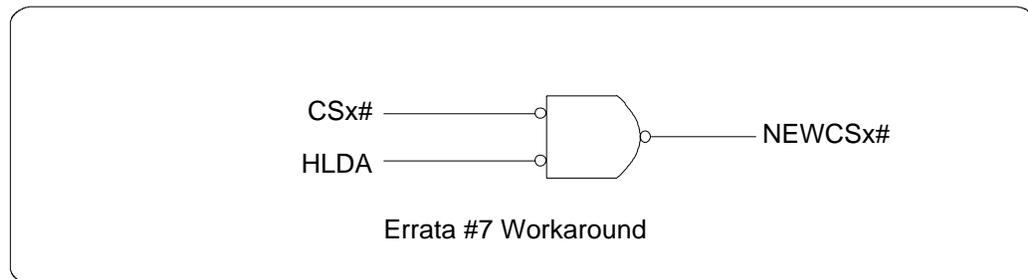
Problem: When the device enters a bus HOLD state because of a HOLD or DMA Cascade operation, the Chip Select that was valid in the previous cycle can remain active during the bus hold. This can cause bus contention when another bus master gains control of the bus.

Workaround: Qualify a chip-select with HLDA such as shown in the circuit below. The chip-select will go inactive if HLDA goes active. If using a PLD device, then HLDA should be used to qualify the chip-select as shown in the following diagram.

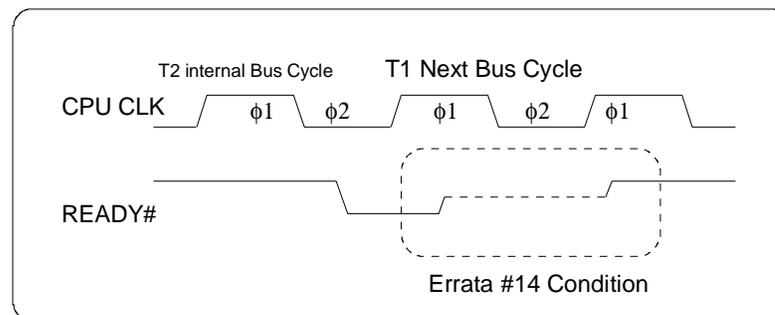
14. READY# Floats In T1 After Internal Bus Cycle Due to LBA#

Problem: During internal bus cycles, the LBA# signal does not remain active into the next T1 bus state, causing READY# to float during T1. This is unlike bus cycles controlled by the Chip Select Unit (CSU), where READY# is driven inactive during T1 of the next bus cycle.

Workaround: Pull-up READY# if the float condition will cause system logic to operate improperly.

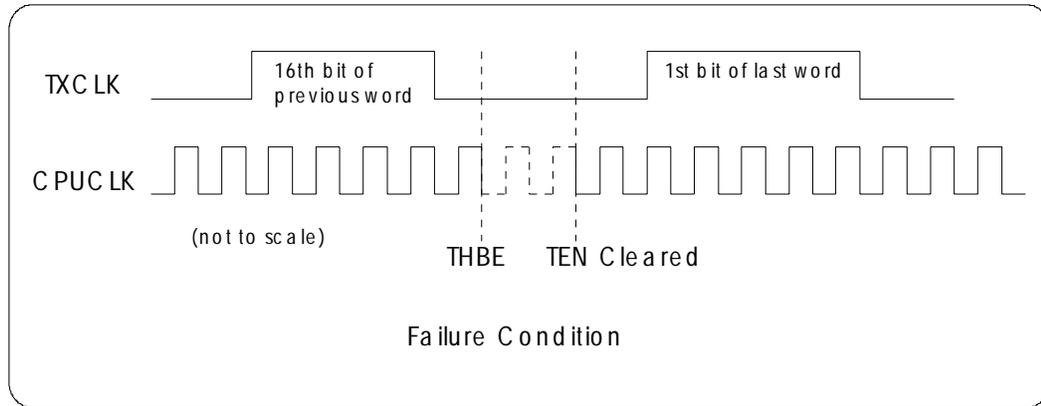
Problem: When the SSIO is transmitting data (master or slave mode) the transmitter is turned off by clearing the TEN bit of the SSIOCON1 register. One way of indicating to the software to clear this bit is by waiting for the Transmit Holding Buffer Empty (THBE) signal to go active, indicating that the word written to the holding register is ready for transmission from the shift register. Even if the software waits for this signal and then writes to SSIOCON1 to disable TEN, depending on when TEN is cleared, the last word transmit may or may not take place.

If the TXCLK is significantly slower than the CPUCLK, it is possible for the THBE bit to be set and the TEN bit to be cleared all during the low time of the TXCLK (see diagram). In this case, even though the last word to be transmitted has been loaded into the shift register, it will not be shifted out.

Workaround: In order to assure that the last word is transmitted, the TEN bit must not be cleared until after the TXCLK transitions from low to high when the 1st bit of the last word is being transmitted. Consequently, the way to assure that this happens is to either: 1) utilize a timer to assure that enough time elapses from when the THBE bit goes high until the TXCLK goes high, or 2) execute a fixed number of NOPs after THBE goes high before clearing TEN. In either case, the length of the delay is dependent upon the frequency of TXCLK and the CPUCLK.

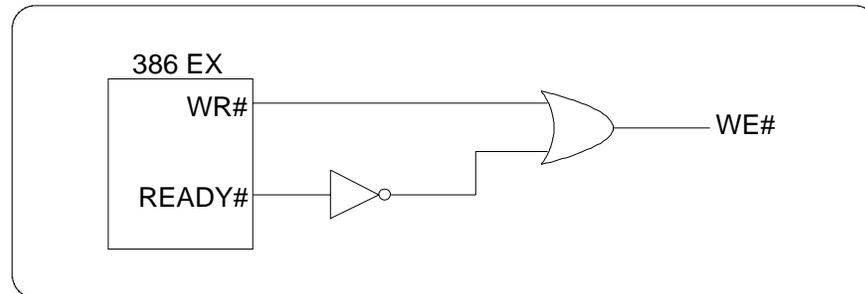
Implication: This errata applies to all applications that use the WR# signal as the write strobe to memory or I/O.

Workaround: The circuit shown below may be used to generate a write strobe if the READY# signal is not generated too early in the T2 cycle. Please note this circuit has not been tested in a real design and is provided as an example only. For applications which cannot use the circuit below it is necessary to implement an external WE# signal using a simple state machine design. An example of what that state machine could look like is available in the EV386EX evaluation board design, or in the Point of Sales Terminal reference design available from the WEB, BBS or through literature.

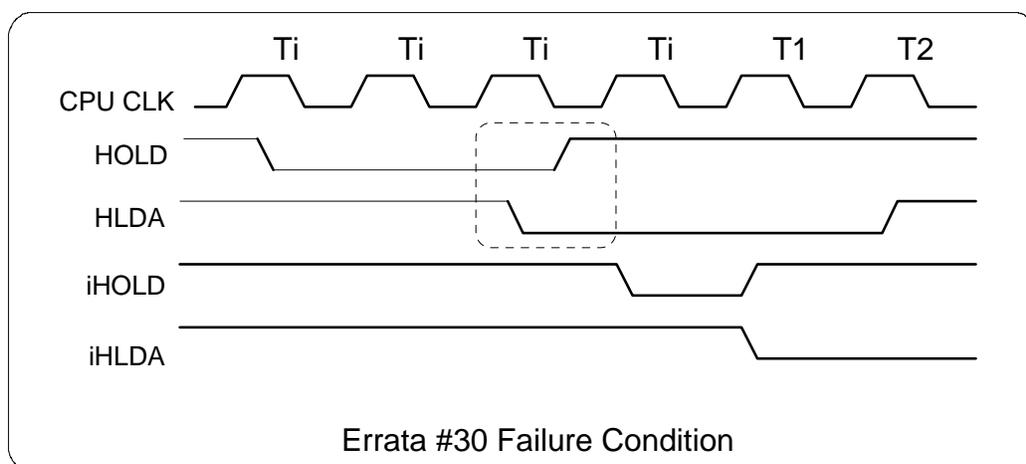
30. HLDA Inactive To HOLD Active Arbitration Could Improperly Float The Bus

Problem: In a HOLD/HLDA cycle the HOLD signal must not be re-asserted until after HLDA is returned inactive. If, however, HOLD is asserted in the same T-state that HLDA goes inactive a problem may occur where the bus arbiter relinquishes control to the core and at the same time floats the bus by asserting the HLDA pin. The following waveform shows the conditions that cause this error. The signals iHOLD and iHLDA are internal signals and represent the HOLD input to the core and the HLDA output from the core (equivalent to the HOLD and HLDA signals on a Intel386™ SX processor). In this diagram a T1 occurs because a request was pending by the core during the previous HOLD cycle. One T-state after the arbiter releases the bus (HLDA = 0) it removes its iHOLD, and then the core removes iHLDA. As soon as the iHLDA is released, the T1 state starts. However, because of the timing of the next HOLD request, the bus arbiter re-asserts iHOLD and HLDA even though the core has not asserted iHLDA. The result is that the core continues to run its bus cycle and, at the same time, the bus arbiter has floated the external bus. It is also possible for the following to occur when HOLD/HLDA arbitration is at issue: HOLD is driven active during the T1 or Tw of a valid bus cycle. The processor begins the next bus cycle and generates HLDA. HLDA is active for only one T-state. ADS# is extended through the bus cycle. The alternate bus master sees the HLDA and performs its bus activity. HOLD is then driven inactive and the bus is returned to the Intel386™ EX Processor. At this point there is bus contention.

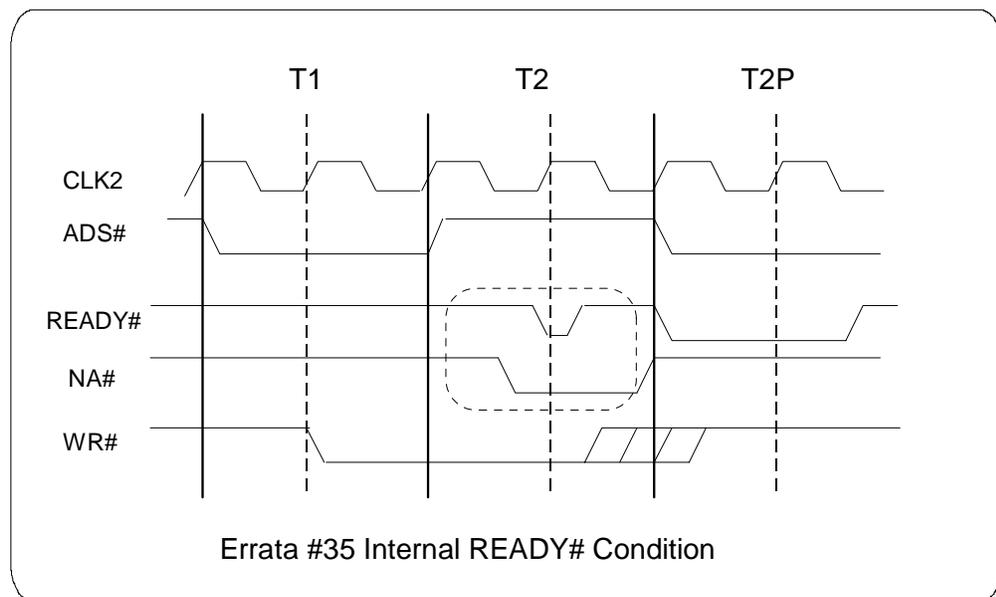
Implication: This errata applies to all applications programming zero wait states on chip select and generating an internal READY#. The temporary transition of READY# will only occur when switching from non-pipeline to pipeline mode.

Workaround: None. Do not trigger any external state machine on asserted READY# signal in T2 unless it occurs at the end of the T2 state where expected.

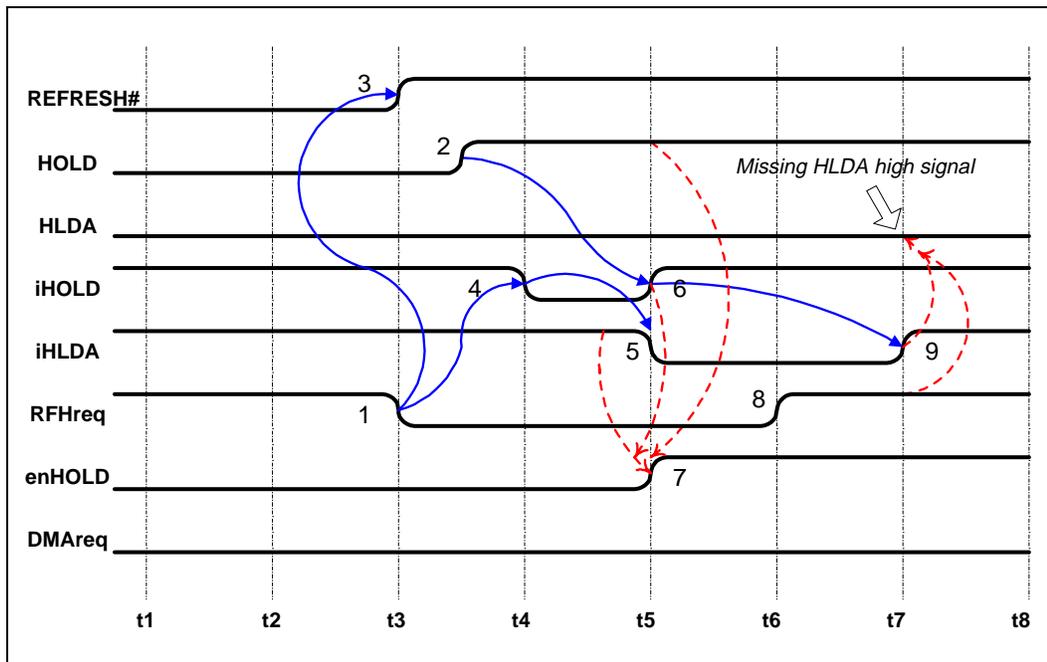
Figure 3. HOLD with Short REFRESH Interval

Figure 3 shows Condition #1a where an external HOLD and refresh request conflict can occur. The table below describes each signal name used:

Workaround: If the situations listed in conditions #1 and #2 cannot be avoided, the user needs to synchronize the external HOLD request such that it does not go active in an idle bus cycle or a refresh cycle. Alternately, HOLD can be deasserted if a HLDA is not received within a time-out period, as described in workaround 2. A third listing describes another recommended workaround when using HOLD, DMA, and REFRESH.

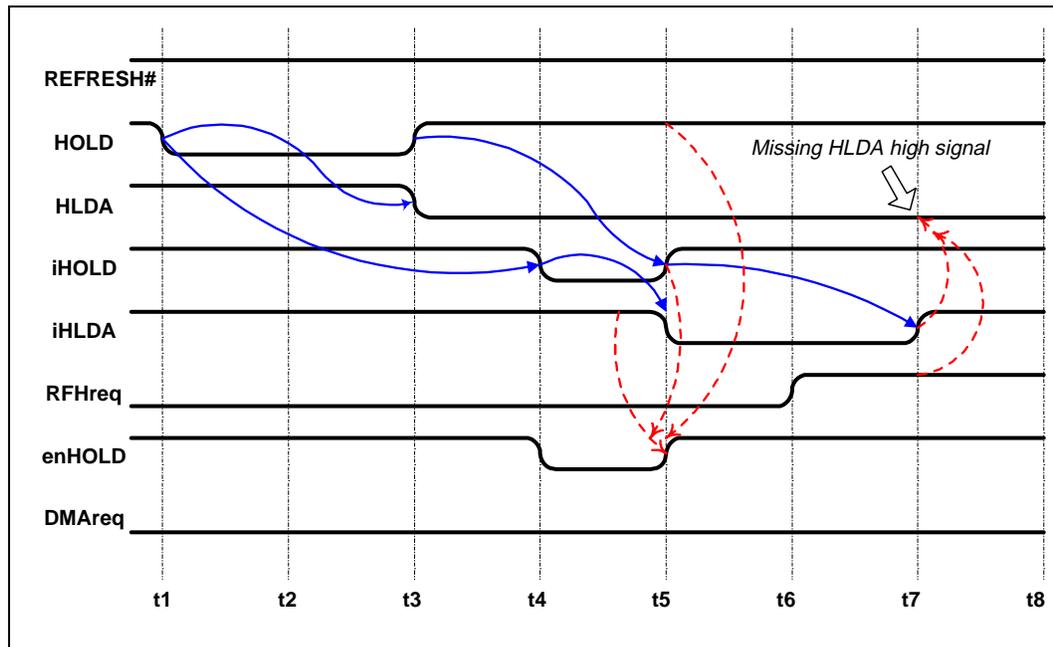
Figure 4. Quick HOLD Assert and Deassert with Slow REFRESH Interval

- b. HOLD is removed and reasserted within one bus cycle. Refer to Figure 4. This condition will cause the problematic window with fast iHOLD deassertion (t4) and assertion (t5). Note that if HOLD is deasserted because of pending REFRESH and reasserted again within one bus cycle, the problem will not occur since the iHOLD signal is never deasserted due to refresh. The reassertion of the HOLD would then be serviced upon completion of the refresh.

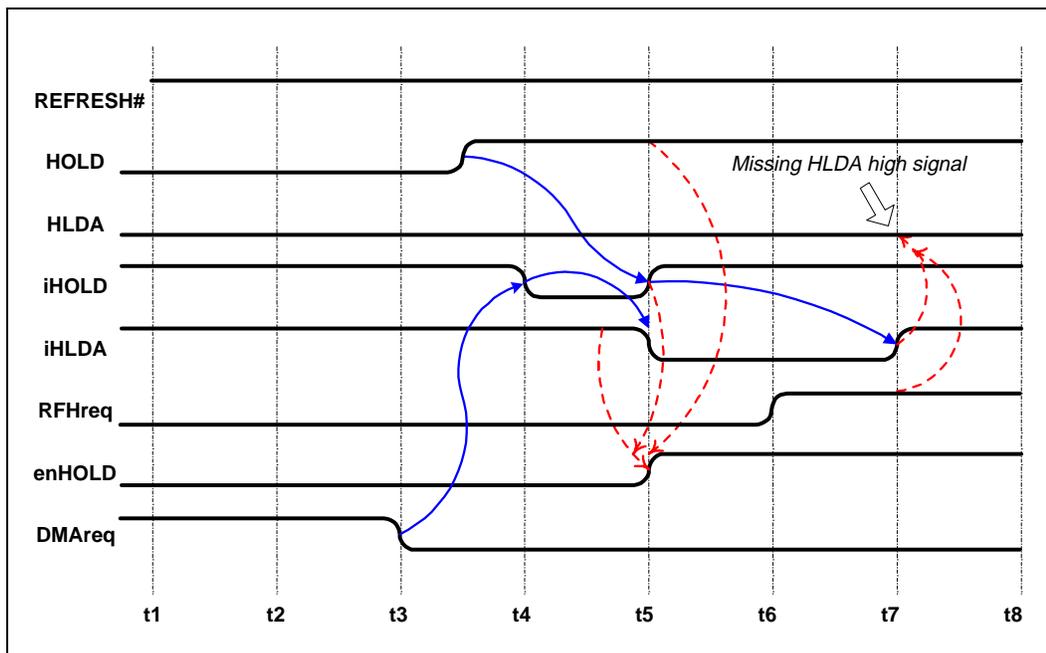
Figure 5. DMA, HOLD and REFRESH with Normal Interval

Note: DMAREQ is a signal internal to the processor. This signal is not always within the user’s control and could be internally deasserted, such as in autoinitialize mode. To avoid issues with this type of situation, it is recommended that the user deassert the external request DREQ after the last transfer has completed. It is further recommended that DREQ only be deasserted after a valid DMA acknowledge (DACK# goes low) has been returned. If a DREQ is held active and then deasserted during or shortly after the autoinitialize sequence, the problematic window can be induced and cause the errata to occur. See errata #28 for additional details on DMA programming restrictions.

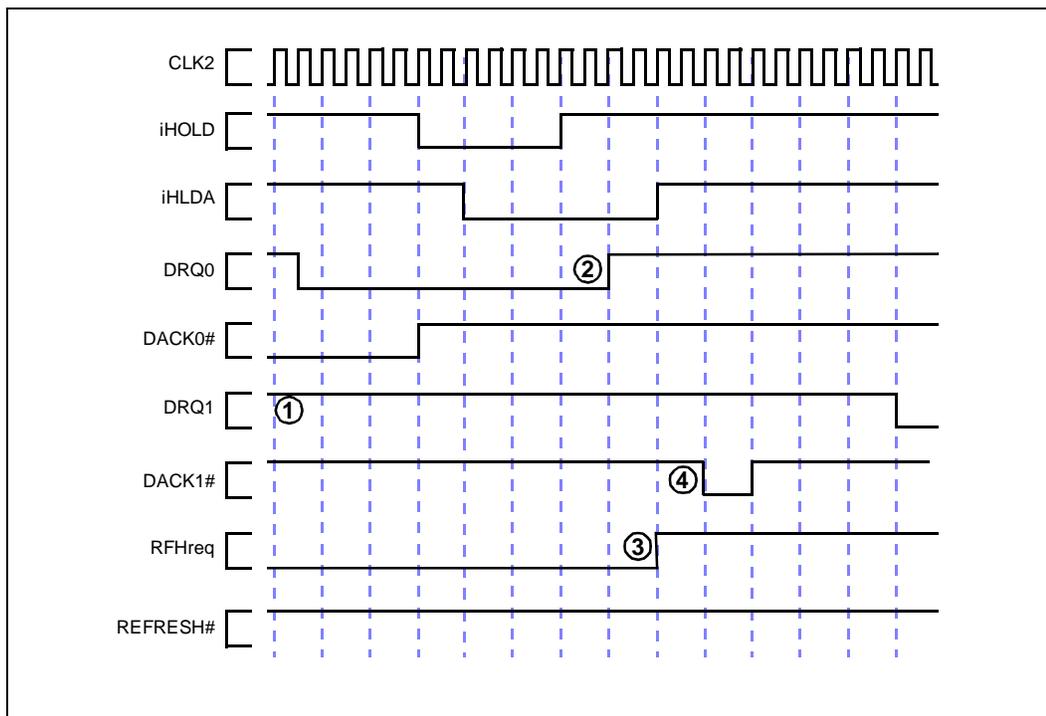
Figure 6. Two DMA Channels in Cascade Mode with Internal RCU Anomaly

The lower priority DMA channel requests the bus by asserting DRQ1 (see 1 in Figure 6). The higher priority channel requests the bus by asserting DRQ0 before the iHLDA has returned from the core (see 2 in Figure 6).

While the Bus Arbiter Unit is in the process of arbitrating priorities between the DMA channels, an internal refresh request signal (RFHreq) is asserted (see 3 in Figure 6) one PH1 cycle before the DMA acknowledge is granted (DACK1# asserted - see 4 in Figure 6). This scenario confuses the bus arbiter and the DMA acknowledge is given to the *lower* priority DMA channel. The arbiter believes the acknowledge was granted to the *higher* priority channel. The DACK1# is quickly taken away from the lower priority channel due to a pending refresh request. DMA channel 1 drops its request, apparently releasing the bus for a REFRESH cycle, but the arbiter is waiting for the higher priority channel to drop its request (DRQ0); this never occurs, since the acknowledge was never granted (DACK0#), and the system hangs.

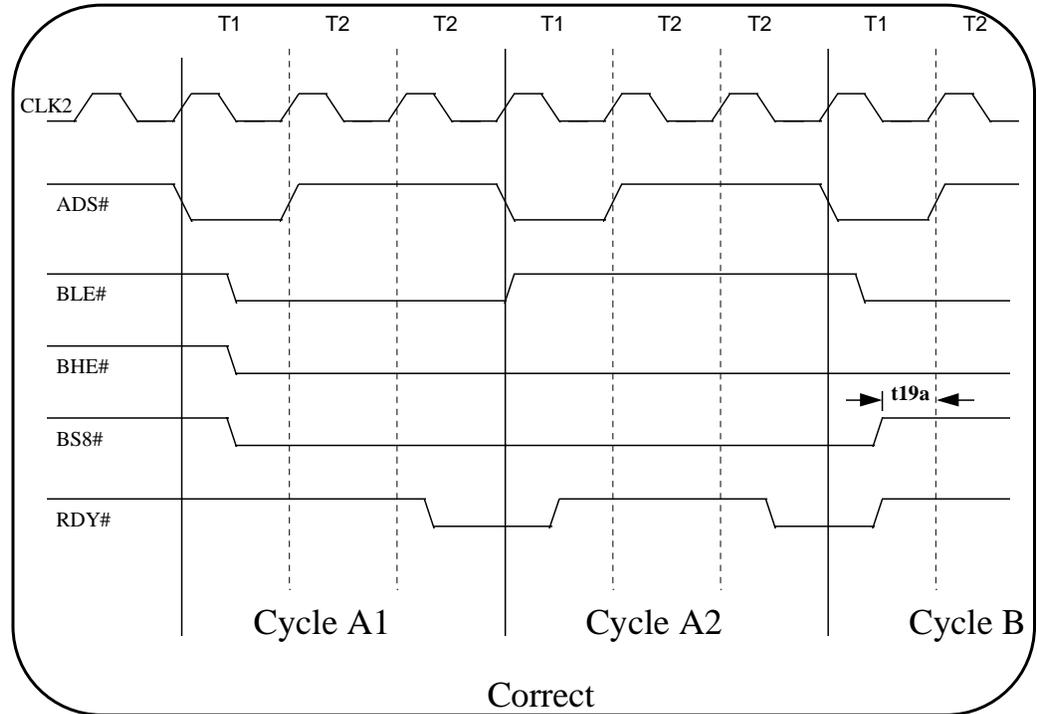
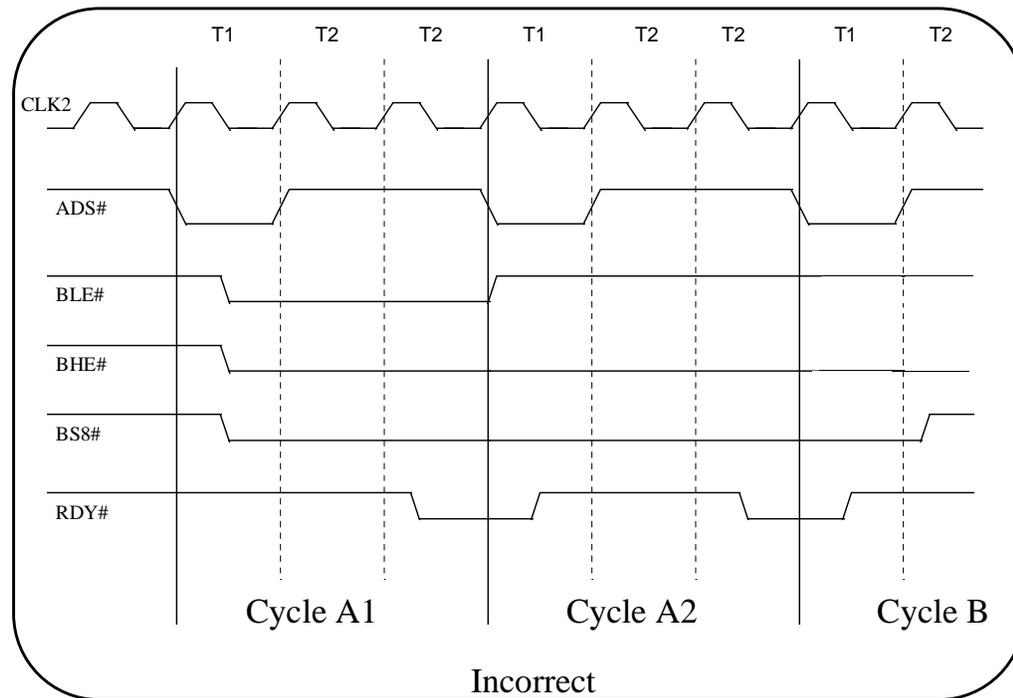
The reason this occurs is as follows: the processor latches the state of BS8# at the beginning of the first T2 of CYCLE B (to perform byte-steering within the processor) and resets this latch only in the next Ti or T1 state. Therefore, if BS8# is kept active into the first T2 of CYCLE B, then the byte-steering logic of the processor incorrectly assumes that CYCLE B is also a cycle to an 8-bit device. This causes the bytes to end up on the wrong data path.

Here are example waveforms demonstrating incorrect vs. proper latching of BS8#:
