Special Environment Intel386™ EX Embedded Processor B-Stepping Device Errata and Feature Enhancements

Presented in this document are known errata for the B-1 step production version of the Special Environment 80386EX embedded processor. (Any processor marked with the DESC number, 5962-9557001xxx, is a B-1 step production part.) A workaround, if known, is also presented. This document will be updated as time progresses to either indicate new errata or to indicate additional workarounds.

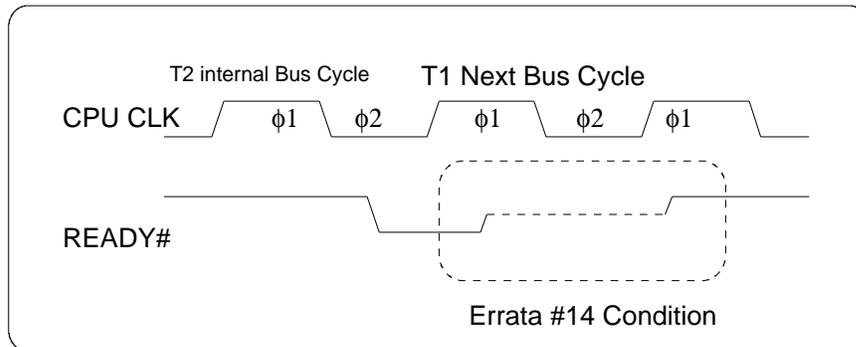
READY# floats in T1 after internal bus cycle

During internal bus cycles, the LBA# signal does not remain active into the next T1 bus state, causing READY# to float during T1. This is unlike bus cycles controlled by the CSU, where READY# is driven inactive during T1 of the next bus cycle.

Pull-up READY# if the float condition will cause system logic to operate improperly.

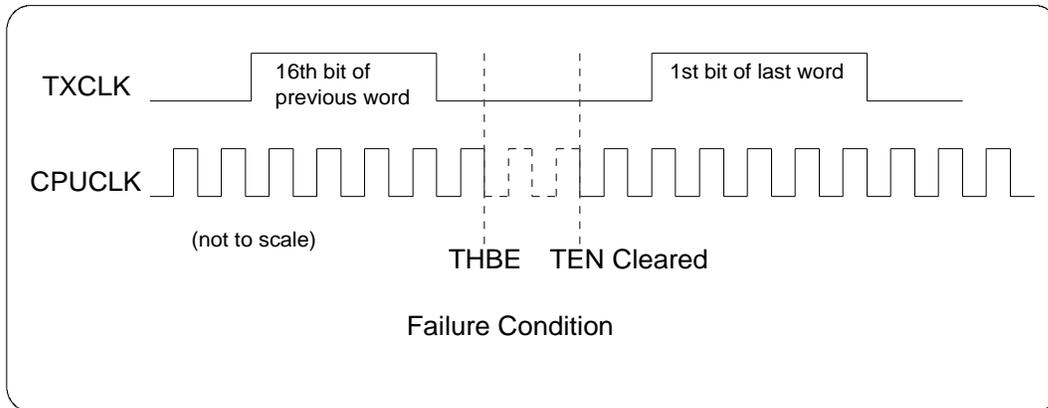
When the SSIO is transmitting data (master or slave mode) the transmitter is turned off by clearing the TEN bit of the SSIOCON1 register. One way of indicating to the software to clear this bit is by waiting for the Transmit Holding Buffer Empty (THBE) signal to go active, indicating that the word written to the holding register is ready for transmission from the shift register. Even if the software waits for this signal and then writes to SSIOCON1 to disable TEN, depending on when TEN is cleared, the last word transmit may or may not take place.

If the TXCLK is significantly slower than the CPUCLK, then it is possible for the THBE bit to be set and the TEN bit to be cleared all during the low time of the TXCLK (see diagram). In this case, even though the last word to be transmitted has been loaded into the shift register, it will not be shifted out.

In order to assure that the last word is transmitted, the TEN bit must not be cleared until after the TXCLK transitions from low to high when the 1st bit of the last word is being transmitted. Consequently, the way to assure that this happens is to either: 1) utilize a timer to assure that enough time elapses from when the THBE bit goes high until the TXCLK goes high, or 2) execute a fixed number of NOPs after THBE goes high before clearing TEN. In either case, the length of the delay is dependent upon the frequency of TXCLK and the CPUCLK.

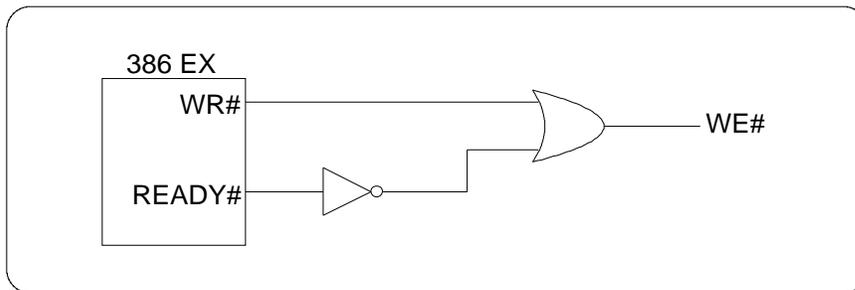
The address hold time after WR# goes high does not meet the data sheet spec of 5nS.

The circuit shown below may be used to generate a write strobe if the READY# signal is not generated too early in the T2 cycle. Please note this circuit has not been tested in a real design and is provided as an example only. For applications cannot use the circuit below it is necessary to implement an external WE# signal using a simple state machine design. An example of what that state machine could look like is available in the EV386EX evaluation board design, or in the Point of Sales Terminal reference design available from the BBS or through literature.

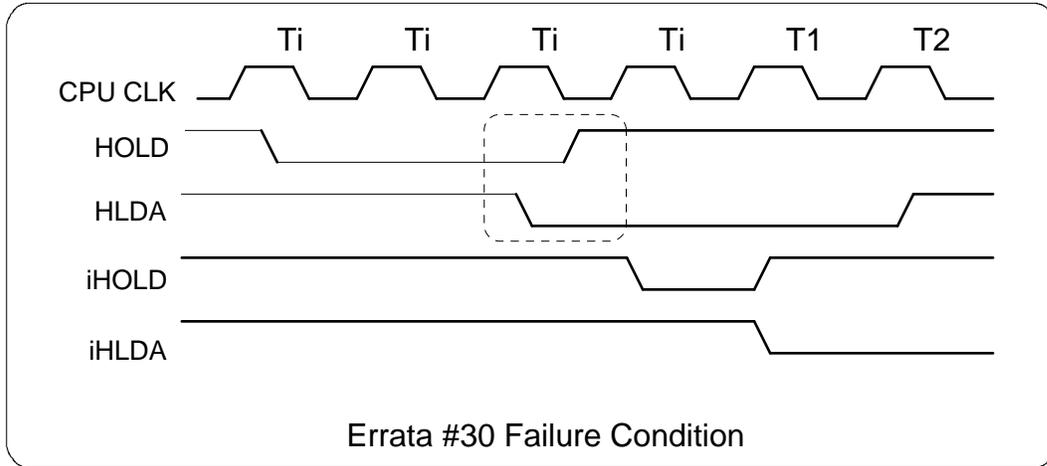
In a HOLD/HLDA cycle the HOLD signal must not be re-asserted until after HLDA is returned inactive. If, however, HOLD is asserted in the same T-state that HLDA goes inactive a problem may occur where the bus arbiter relinquishes control to the core and at the same time floats the bus by asserting the HLDA pin. The following waveform shows the conditions that cause this error. The signals iHOLD and iHLDA are internal signals and represent the HOLD input to the core and the HLDA output from the core (equivalent to the HOLD and HLDA signals on a 386SX processor). In this diagram a T1 occurs because a request was pending by the core during the previous HOLD cycle. One T-state after the arbiter releases the bus (HLDA = 0) it removes its iHOLD, and then the core removes iHLDA. As soon as the iHLDA is released the T1 state starts. However,

because of the timing of the next HOLD request, the bus arbiter re-asserts iHOLD and HLDA even though the core has not asserted iHLDA. The result is that the core continues to run its bus cycle and, at the same time, the bus arbiter has floated the external bus.
