80C186EB/80C188EB AND 80L186EB/80L188EB EMBEDDED MICROPROCESSORS SPECIFICATION UPDATE

Release Date: April, 1998
Order Number: 272897-005

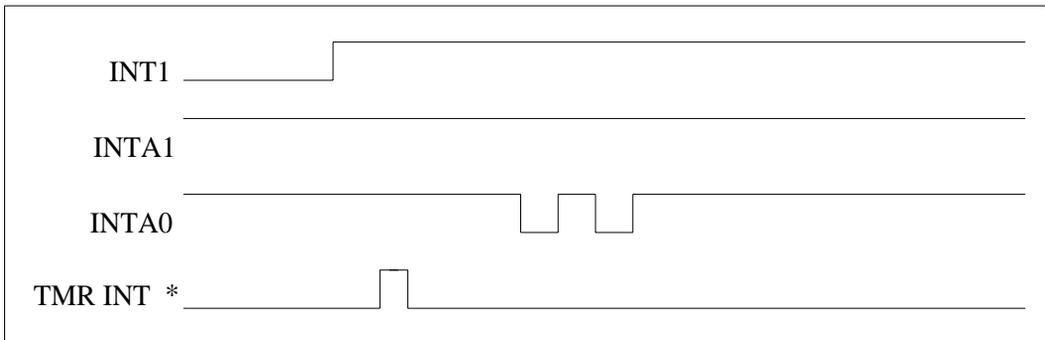
Figure 3. INT0 And INT1 Acknowledge Failure due to Higher Priority Timer Interrupt

If INT0 and INT1 are configured in cascade mode and a higher priority interrupt occurs between INT1 and its expected acknowledge, then the acknowledge will appear on INTA0# instead (Figure 3).

*Note: This interrupt could be any of the following: DMA, Timers, Serial, or INT0.

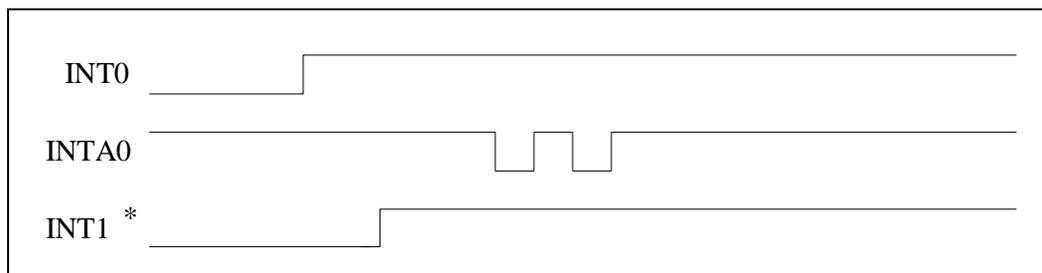
Figure 4. Correct INT0 Acknowledge Operation with a Simultaneous INT1

Correct operation acknowledges INT0 on INTA0#. Normally, this occurs even if there is a higher priority INT1 after INT0 but before the acknowledge (Figure 4).

*Note: INT1 is the only interrupt that causes the errata to occur.

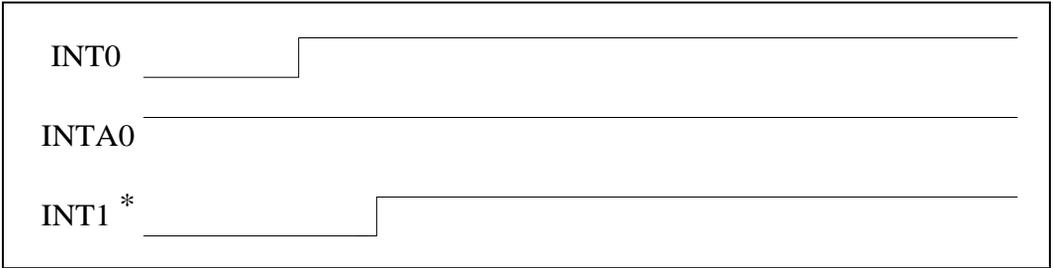
Figure 5. Incorrect INT0 Acknowledge Operation with a Simultaneous INT1

The errata occurs when INT1, which is higher priority than INT0, occurs between INT0 and its expected acknowledge. The processor completes internal interrupt acknowledge cycles as seen on the status lines but no acknowledge cycle is sent on the INTA0# output (Figure 5).

*Note: This problem occurs only if INT1 is higher priority than INT0.

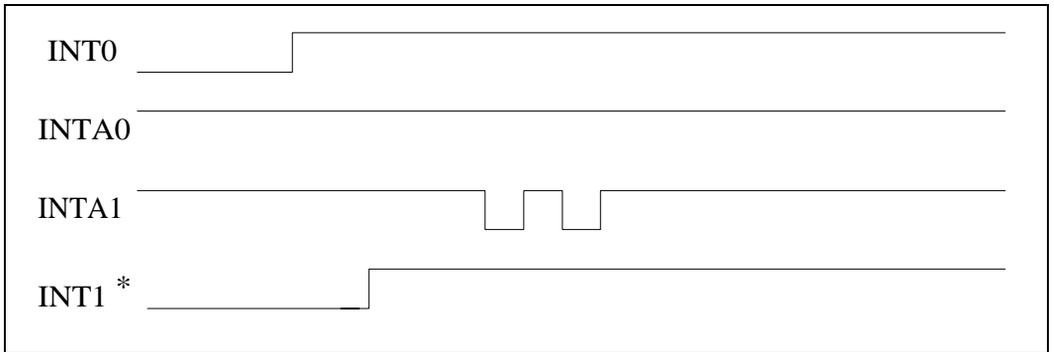
Figure 6. INT0 and INT1 Acknowledge Failure Due to the Higher Priority INT1

If INT0 and INT1 are configured in cascade mode and the higher priority INT1 occurs between INT0 and its expected acknowledge, then the acknowledge will appear on INTA1# instead of INTA0# (Figure 6).

*Note: This problem occurs only if INT1 is higher priority than INT0.

1. Pull data bus lines 0 to 7 to a known value (using pull-up resistors) to force a defined value on the bus when the errata occurs.

2. Program cascaded interrupt inputs on the 186 to be level sensitive; otherwise, the 186 does not recognize that the interrupt is still active.
3. Write a simple service routine for the interrupt type defined in step 1.

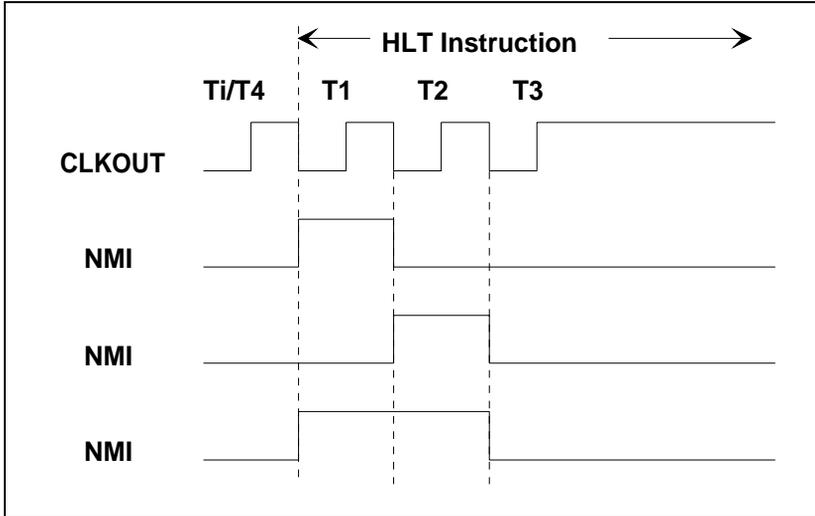
Figure 7. NMI Ignored During HLT Entering Powerdown

The problem occurs when an NMI occurs during execution of the HLT instruction. NMI is only serviced at valid instruction boundaries. The HLT instruction, when entering Powerdown, does not really have a boundary, it extends until Powerdown is exited. If NMI occurs between the beginning the T1 bus state and the end of the T2 state, but does not extend into T3, it will not be recognized, and the processor will enter Powerdown mode. The processor does not recognize the NMI request during the HLT instruction until the internal clock has stopped (at the end of T2).

The figures below show NMI occurring at different times during execution of the HLT instruction. Two cases are shown. **Figure 7** shows cases where NMI is not recognized. **Figure 8** shows cases where NMI is recognized. Both cases assume setup and hold time requirements are met for the NMI input.

In a typical system design using Powerdown mode, NMI can only occur after Powerdown is entered and the clock is stopped. The simplest solution to the problem is to not assert NMI unless the processor has entered Powerdown Mode.

If the system requires periodic NMI pulses, then the NMI pulse width must be long enough to ensure that it will extend into the T3 state of the HLT instruction. A NMI pulse width of three CLKOUT periods guarantees this.

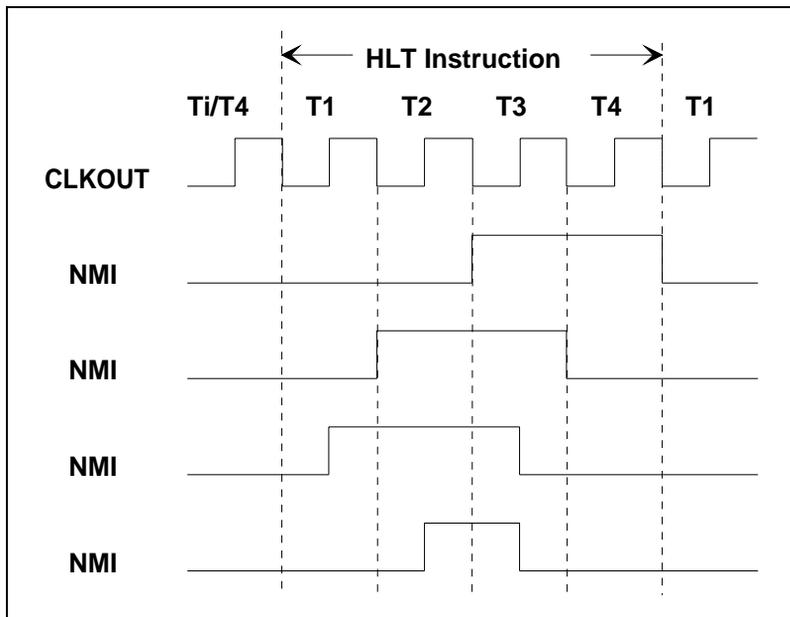
Figure 8. NMI recognized during HLT entering Powerdown

For the NMI to be recognized during the execution of the HLT instruction, the pulse must extend into T3. At this point, the processor has entered Powerdown and synchronized the NMI pulse. The NMI will be processed, but the processor will never enter Powerdown. Essentially, because NMI is active, the processor exits Powerdown as soon as it enters.
