Pentium[®] Processor for Embedded Applications

Specification Update

January 1999

Order Number: 273183-003

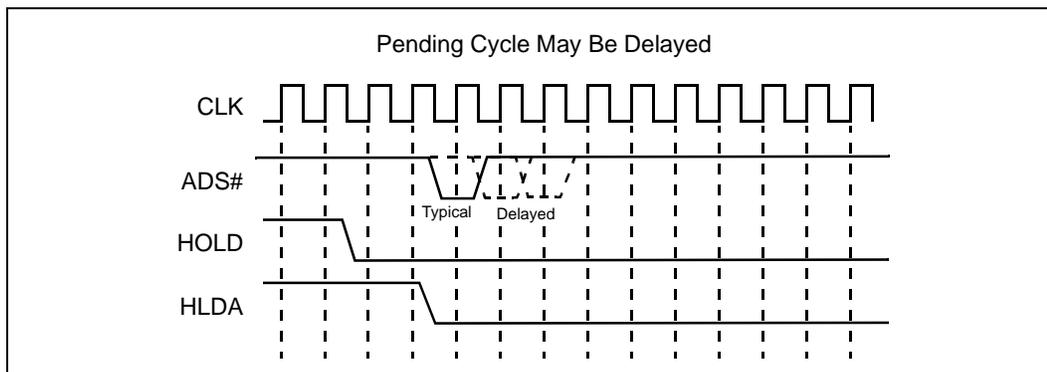
69. ADS# May be Delayed After HLDA Deassertion

Problem: The Pentium processor typically starts a pending bus cycle on the same clock that HLDA is deasserted and the Pentium processor with MMX technology typically starts the cycle one clock after HLDA is deasserted. However, in both processors it may be delayed by as many as two clocks. See the diagram below:

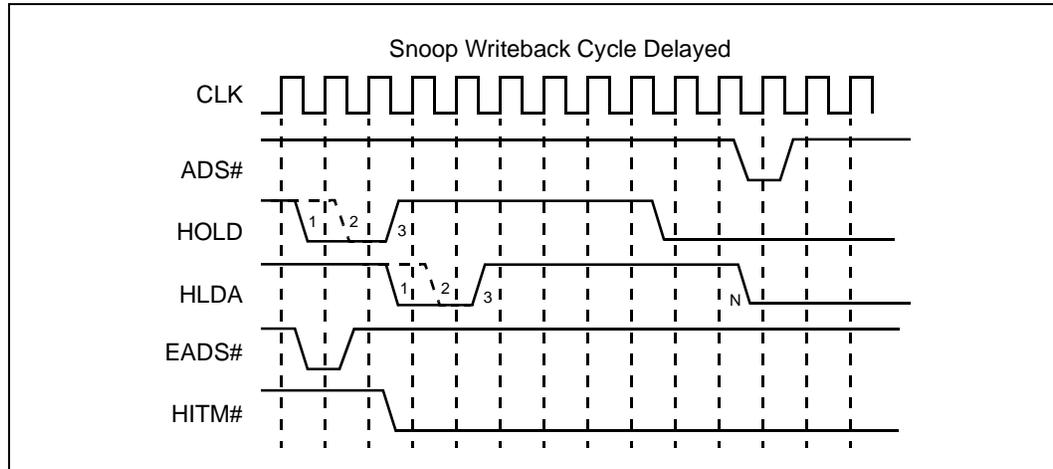
In two cases, for example, if HOLD is deasserted for one clock (i.e., clock 2) or two clocks (i.e., clocks 1 & 2) and then reasserted, the window may not be large enough to start a pending snoop writeback cycle. The writeback cycle may be delayed until the HLDA is deasserted again (i.e., clock N). See diagram below.

Implication: If the system expects a cycle, for example a writeback cycle, and depends on this cycle to commence within the HLDA deassertion window, then the system may not complete the handshake and cause a hang.

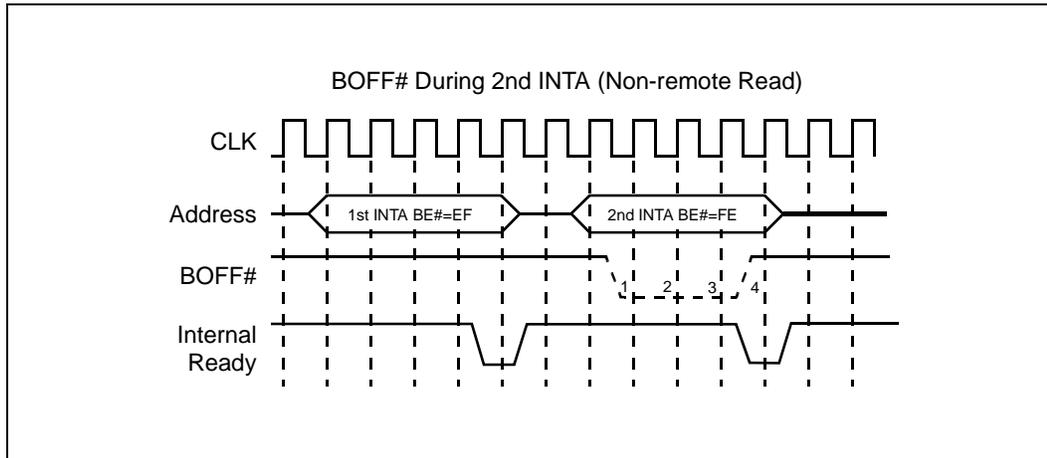
If these conditions occur while a remote read message is being sent or received, the second INTA cycle may take up to 8 clocks to complete (counting from clock 1). BOFF# is not latched and must remain asserted until after the 2nd INTA completes (e.g., for 8 clocks).

Similarly, if HOLD is asserted anytime during the second INTA cycle, and during a remote read, the processor will hang.

Implication: If the system does not assert BOFF# when the processor bus is idle, then this problem will not occur. Internal APIC INTA cycles are run only when the bus is idle, thus asserting BOFF# during an external bus cycle (e.g., started by an ADS#) will avoid these circumstances. In systems that can assert BOFF# when the bus is idle, asserting BOFF# for a least 4 clocks will avoid the problem for non-remote read cases. Note that there may be other implementations that guarantee BOFF# is not asserted in the problematic window. For example, if BOFF# is only asserted with AHOLD active and AHOLD always precedes BOFF# by at least 4 clocks, the erratum is avoided.
