# **AMD-K6<sup>®</sup>-2**

## **Processor Revision Guide**

### **Model 8**

Publication # <b>21641</b> Rev: <b>F</b> Amendment/ <b>0</b> Issue Date: <b>June 1999</b>
--

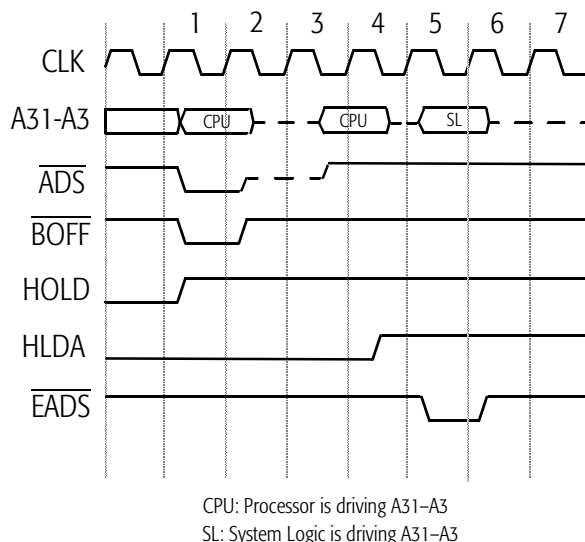
**Figure 1. AMD-K6<sup>®</sup>-2 Processor Assertion of HLDA Due to Simultaneous  $\overline{BOFF}$ /HOLD Assertion**

**Non-conformance.** If  $\overline{\text{BOFF}}$  and HOLD are sampled asserted on the same clock edge that negates  $\overline{\text{ADS}}$ , the processor asserts HLDA two clock edges after HOLD is sampled asserted.

- If the system logic asserts  $\overline{\text{BOFF}}$  for a duration of one clock, anticipates the assertion of HLDA in clock 3 (see Figure 1)—which is the normal specified operation—and drives the address bus and  $\overline{\text{EADS}}$  for an inquire cycle in clock 3, then the processor will not sample  $\overline{\text{EADS}}$  asserted. In addition, address bus contention will occur in clock 3.

- If the system logic asserts  $\overline{\text{BOFF}}$  for a duration of two clocks, anticipates the assertion of HLDA in clock 3, and drives the address bus and  $\overline{\text{EADS}}$  for an inquire cycle in clock 3, then the processor will not sample  $\overline{\text{EADS}}$  asserted. (No address bus contention occurs in this case.)

- If the system logic asserts  $\overline{\text{BOFF}}$  for a duration of one clock, anticipates the assertion of HLDA in clock 3, and drives the address bus and  $\overline{\text{EADS}}$  for an inquire cycle in clock 4, then address bus contention may occur in clock 4. (The processor will sample  $\overline{\text{EADS}}$  asserted in this case.)

If the processor does not sample  $\overline{\text{EADS}}$  asserted during an inquire cycle, cache/memory incoherency will occur. Address bus contention can affect the reliability of the processor and the system logic.

**Suggested Workaround.** The system logic must sample the assertion of HLDA before asserting  $\overline{\text{EADS}}$  and driving the address bus for an inquire cycle—as shown in clock 5 of Figure 1.
