# **80C186EA/80C188EA AND 80L186EA/80L188EA EMBEDDED MICROPROCESSORS SPECIFICATION UPDATE**

Release Date: August, 1997

Order Number: 272896-003

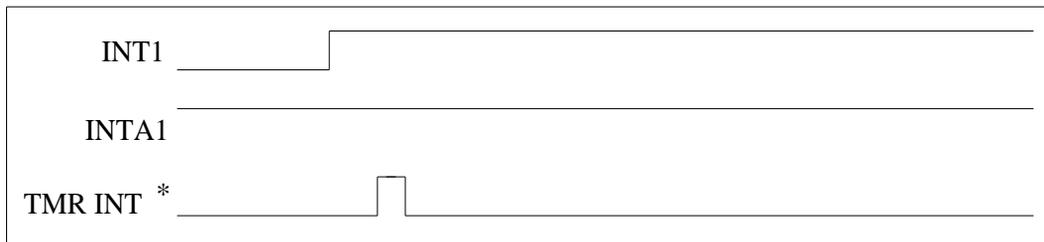
**Figure 2. Incorrect INT1 Acknowledge Sequence with Higher Priority Timer Interrupt**

The errata occurs when a higher priority interrupt occurs between INT1 and its expected acknowledge. The processor completes internal interrupt acknowledge cycles as seen on the status lines but no acknowledge cycle is sent on the INTA1# output (Figure 2).

\*Note: This interrupt could be any of the following: DMA, Timers, Serial, INT0, or INT2.

| 1. Only INT1 is configured in cascade mode and is lower priority than at least one other interrupt. | Use only INT0 in cascade mode instead, or make INT1 the highest priority interrupt, or use hardware workaround. |

1. Pull data bus lines 0 to 7 to a known value (using pull-up resistors) to force a defined value on the bus when the errata occurs.

These resistors will pull the floated bus to 0FFH during the 186 interrupt acknowledge cycle. A type 255 interrupt will be read from the bus and executed. An interrupt service routine for a type 255 interrupt should be included in the software. This solution allows a graceful recovery from the errata condition. If the current design uses interrupt type 255, the resistors can be selectively connected to  $V_{CC}$  or Ground to define an unused interrupt type.

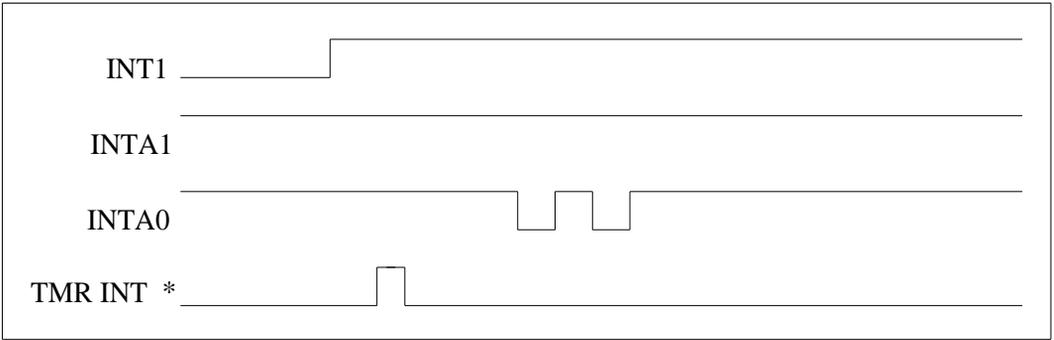
**Figure 3. INT0 And INT1 Acknowledge Failure due to Higher Priority Timer Interrupt**

If INT0 and INT1 are configured in cascade mode and a higher priority interrupt occurs between INT1 and its expected acknowledge, then the acknowledge will appear on INTA0# instead (Figure 3).

\*Note: This interrupt could be any of the following: DMA, Timers, Serial, or INT0.

| 2. INT1 and INT0 are both in cascade mode. | Use only one interrupt in cascade mode, or use hardware workaround. |

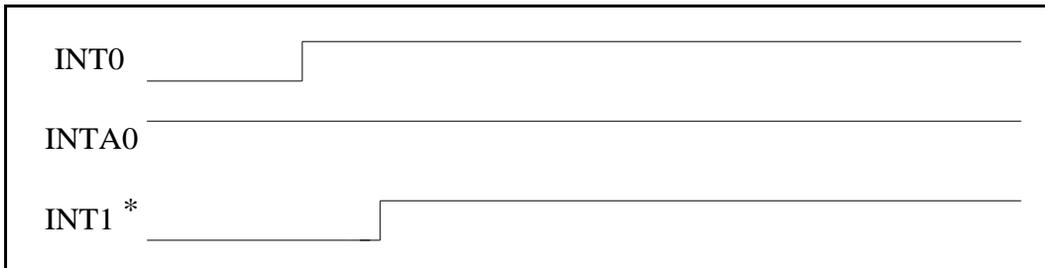
**Figure 5. Incorrect INT0 Acknowledge Operation with a Simultaneous INT1**

The errata occurs when INT1, which is higher priority than INT0, occurs between INT0 and its expected acknowledge. The processor completes internal interrupt acknowledge cycles as seen on the status lines but no acknowledge cycle is sent on the INTA0# output (Figure 5).

\*Note: This problem occurs only if INT1 is higher priority than INT0.

| 3. Only INT0 is configured in cascade mode and is lower priority than INT1. | Make INT0 higher priority than INT1, or use hardware workaround. |

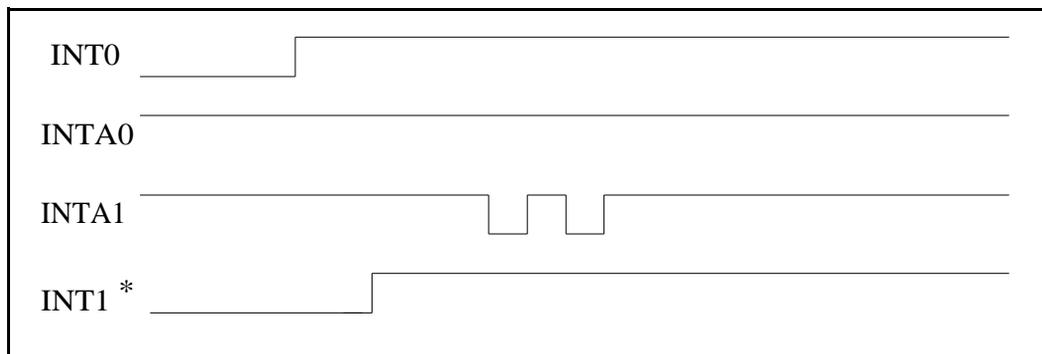
**Figure 6. INT0 and INT1 Acknowledge Failure Due to the Higher Priority INT1**

If INT0 and INT1 are configured in cascade mode and the higher priority INT1 occurs between INT0 and its expected acknowledge, then the acknowledge will appear on INTA1# instead of INTA0# (Figure 6).

\*Note: This problem occurs only if INT1 is higher priority than INT0.

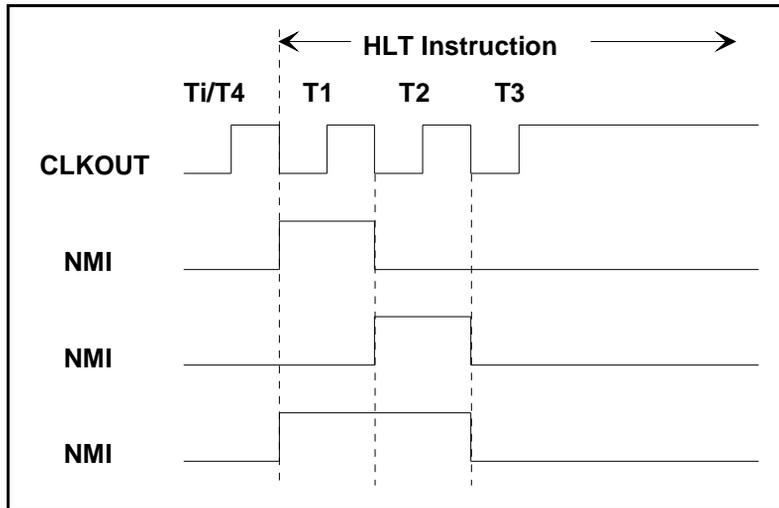
Figure 7. NMI Ignored During HLT Entering Powerdown

The problem occurs when an NMI occurs during execution of the HLT instruction. NMI is only serviced at valid instruction boundaries. The HLT instruction, when entering Powerdown, does not really have a boundary, it extends until Powerdown is exited. If NMI

occurs between the beginning the T1 bus state and the end of the T2 state, but does not extend into T3, it will not be recognized, and the processor will enter Powerdown mode. The processor does not recognize the NMI request during the HLT instruction until the internal clock has stopped (at the end of T2).

In a typical system design using Powerdown mode, NMI can only occur after Powerdown is entered and the clock is stopped. The simplest solution to the problem is to not assert NMI unless the processor has entered Powerdown Mode.

If the system requires periodic NMI pulses, then the NMI pulse width must be long enough to ensure that it will extend into the T3 state of the HLT instruction. A NMI pulse width of three CLKOUT periods guarantees this.

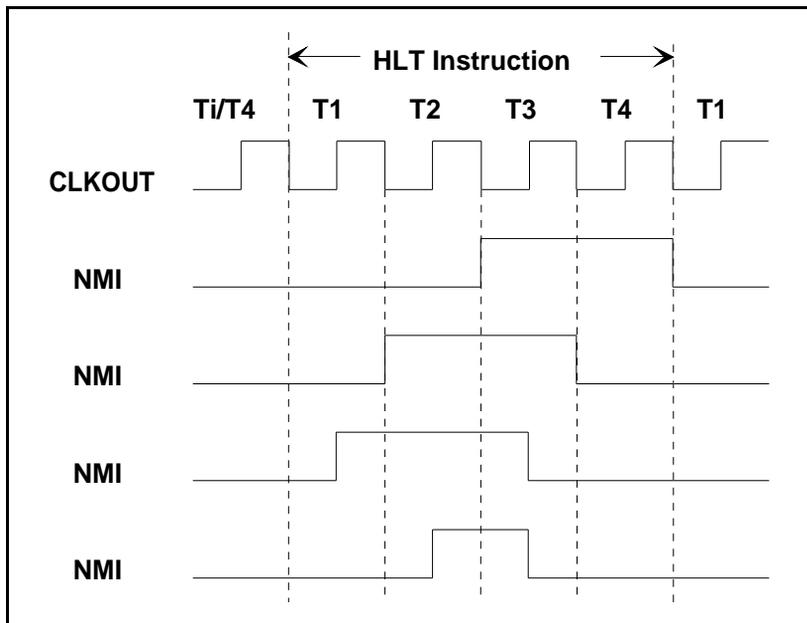
Figure 8. NMI Recognized During HLT Entering Powerdown

For the NMI to be recognized during the execution of the HLT instruction, the pulse must extend into T3. At this point, the processor has entered Powerdown and synchronized the NMI pulse. The NMI will be processed, but the processor will never enter Powerdown. Essentially, because NMI is active, the processor exits Powerdown as soon as it enters.
