80C186EC/80C188EC AND 80L186EC/80L188EC EMBEDDED MICROPROCESSORS SPECIFICATION UPDATE

Release Date: June, 1997
Order Number: 272898-002

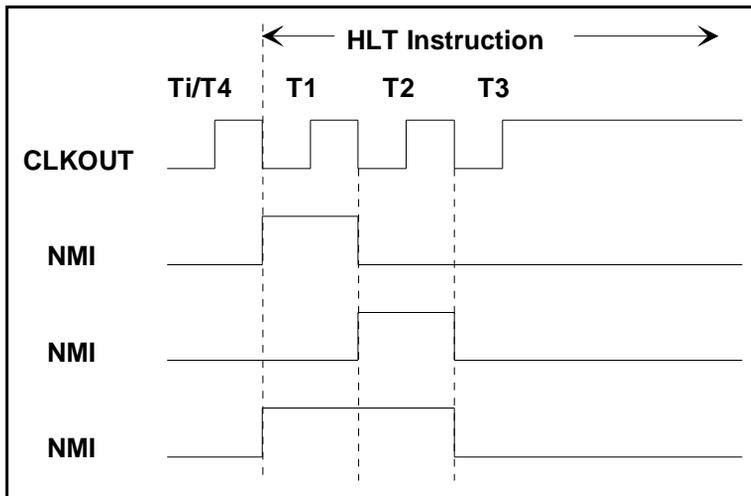
The problem occurs when an NMI occurs during execution of the HLT instruction. NMI is only serviced at valid instruction boundaries. The HLT instruction, when entering Powerdown, does not really have a boundary, it extends until Powerdown is exited. If NMI occurs between the beginning the T1 bus state and the end of the T2 state, but does not extend into T3, it will not be recognized, and the processor will enter Powerdown mode. The processor does not recognize the NMI request during the HLT instruction until the internal clock has stopped (at the end of T2).

Figure 1. NMI Ignored During HLT Entering Powerdown

If the system requires periodic NMI pulses, then the NMI pulse width must be long enough to ensure that it will extend into the T3 state of the HLT instruction. A NMI pulse width of three CLKOUT periods guarantees this.

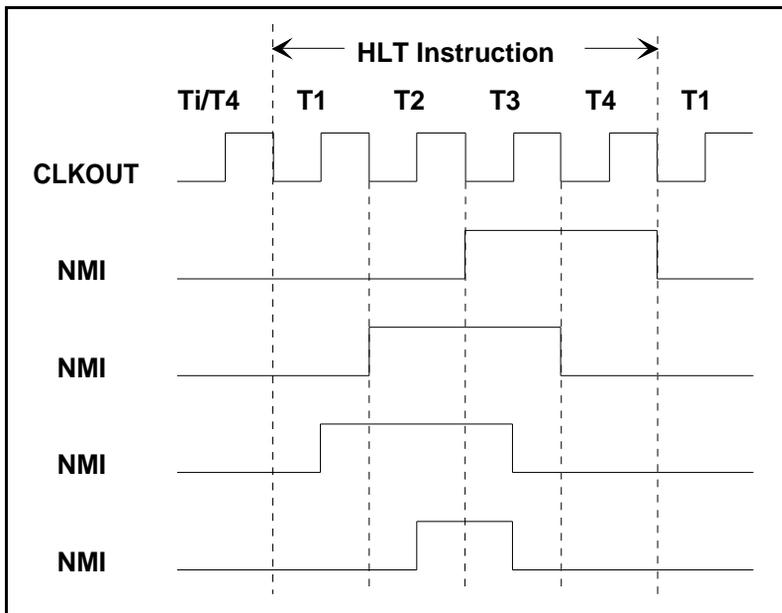
For the NMI to be recognized during the execution of the HLT instruction, the pulse must extend into T3. At this point, the processor has entered Powerdown and synchronized the NMI pulse. The NMI will be processed, but the processor will never enter Powerdown. Essentially, because NMI is active, the processor exits Powerdown as soon as it enters.

Figure 2. NMI Recognized During HLT Entering Powerdown
