# Pentium<sup>®</sup> Processor for Embedded Applications

Specification Update

*July 1998*

Order Number: 273183-001

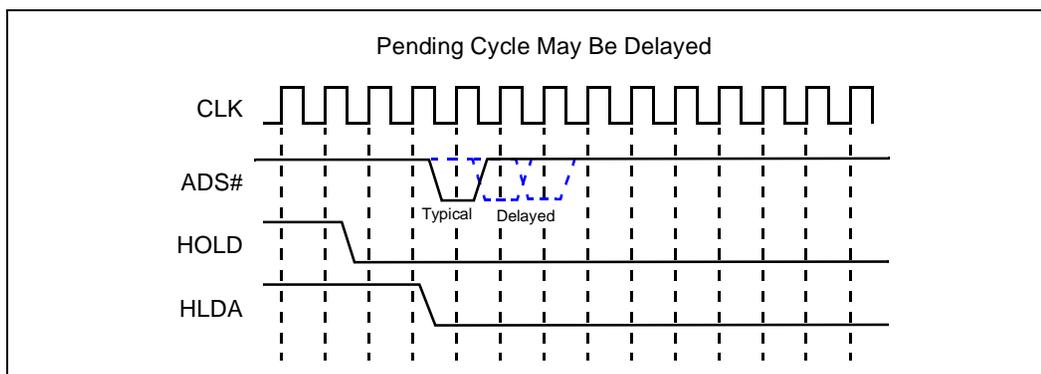
**69. ADS# May be Delayed After HLDA Deassertion**

**Problem:** The Pentium processor typically starts a pending bus cycle on the same clock that HLDA is deasserted and the Pentium processor with MMX technology typically starts the cycle one clock after HLDA is deasserted. However, in both processors it may be delayed by as many as two clocks. See the diagram below:

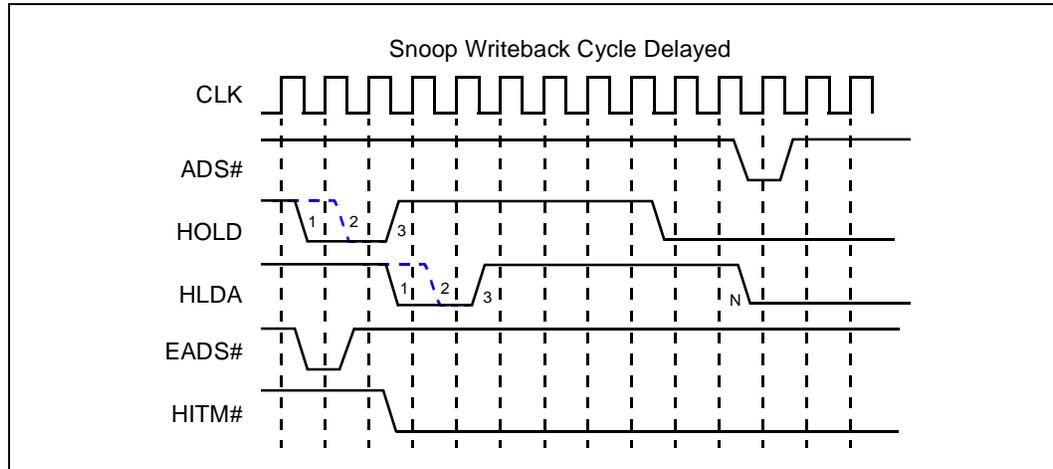
In two cases, for example, if HOLD is deasserted for one clock (i.e., clock 2) or two clocks (i.e., clocks 1 & 2) and then reasserted, the window may not be large enough to start a pending snoop writeback cycle. The writeback cycle may be delayed until the HLDA is deasserted again (i.e., clock N). See diagram below.

**Implication:** If the system expects a cycle, for example a writeback cycle, and depends on this cycle to commence within the HLDA deassertion window, then the system may not complete the handshake and cause a hang.

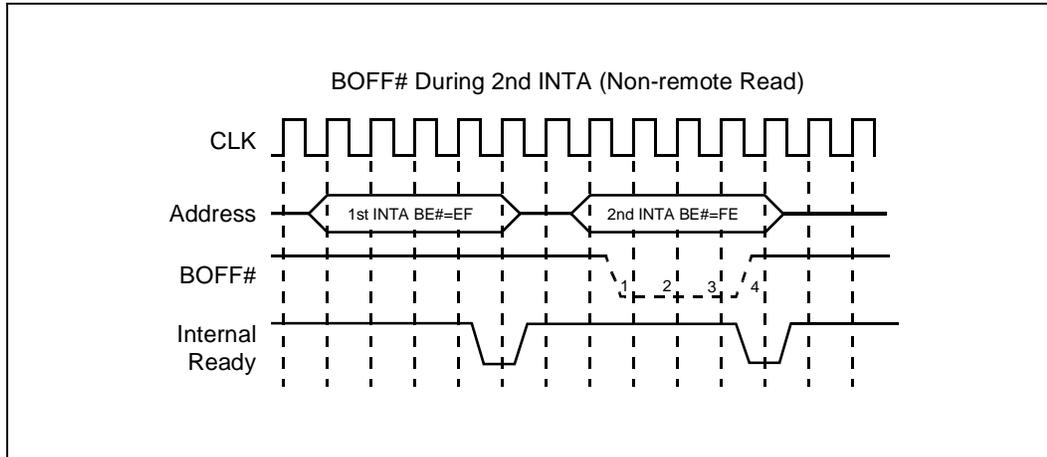
If these conditions occur while a remote read message is being sent or received, the second INTA cycle may take up to 8 clocks to complete (counting from clock 1). BOFF# is not latched and must remain asserted until after the 2nd INTA completes (e.g., for 8 clocks).

Similarly, if HOLD is asserted anytime during the second INTA cycle, and during a remote read, the processor will hang.

**Implication:** If the system does not assert BOFF# when the processor bus is idle, then this problem will not occur. Internal APIC INTA cycles are run only when the bus is idle, thus asserting BOFF# during an external bus cycle (e.g., started by an ADS#) will avoid these circumstances. In systems that can assert BOFF# when the bus is idle, asserting BOFF# for a least 4 clocks will avoid the problem for non-remote read cases. Note that there may be other implementations that guarantee BOFF# is not asserted in the problematic window. For example, if BOFF# is only asserted with AHOLD active and AHOLD always precedes BOFF# by at least 4 clocks, the erratum is avoided.

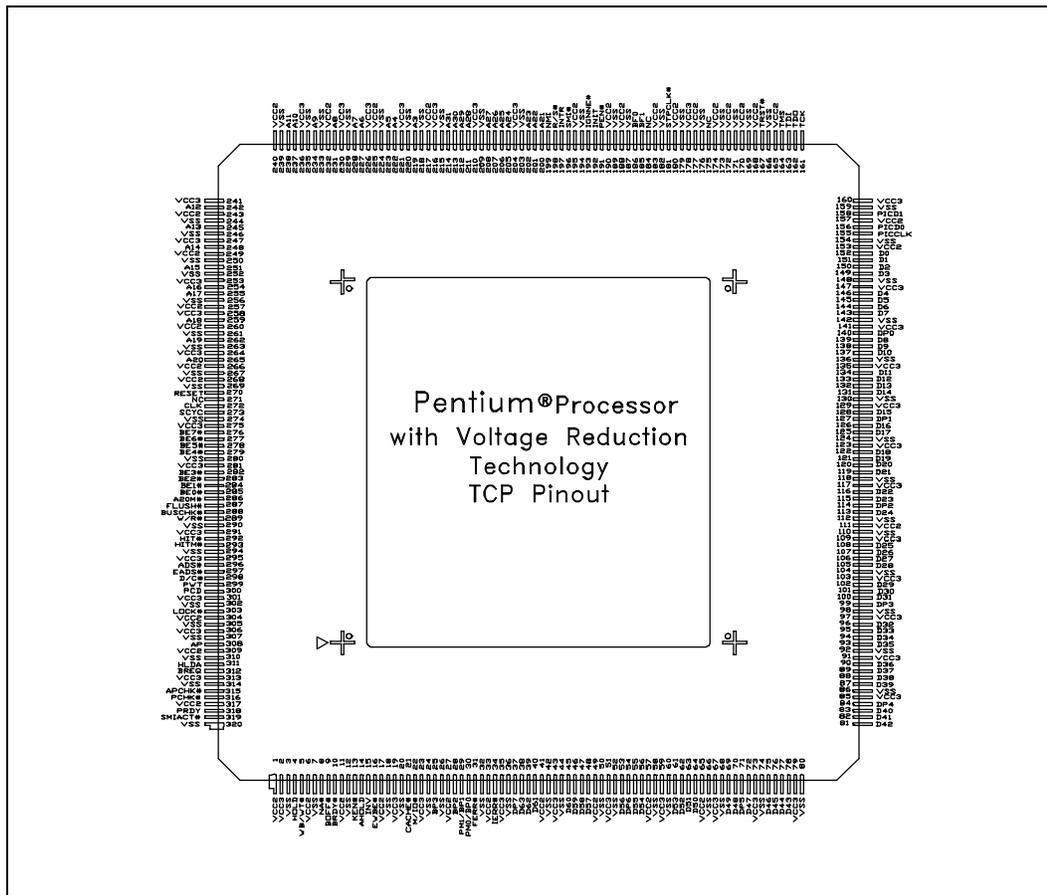
## 2. Incorrect TCP Pinout Drawing

The TCP pinout drawing on page 8 of the *Pentium Processor with Voltage Reduction Technology* datasheet was inadvertently rotated. The correct orientation is shown below.
