Pentium® Processor Specification Update

Release Date: October 1997

Order Number: 242480-031

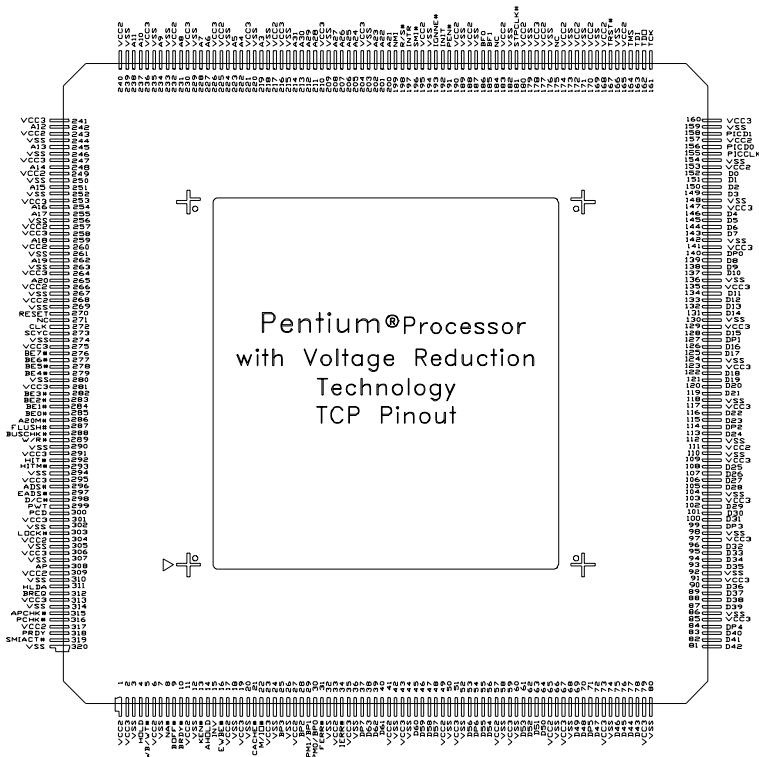
2. **Incorrect TCP Pinout Drawing**

The TCP pinout drawing on page 8 of the *Pentium Processor with Voltage Reduction Technology* datasheet was inadvertently rotated. The correct orientation is shown below.

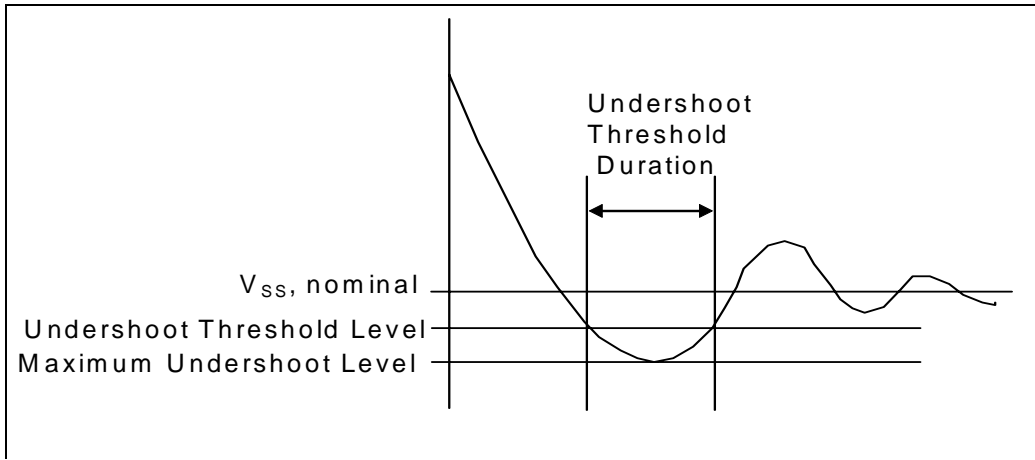
Figure 14-1. Maximum Undershoot Level, Undershoot Threshold Level, and Undershoot Threshold Duration

UNDERSHOOT THRESHOLD DURATION SPECIFICATION: A snapshot of the clock signal should be taken at 500 mV/div and 500 pS/div (for CLK). Adjust the vertical position and horizontal offset position to view the threshold duration. The undershoot threshold duration is defined as the sum of all time during which the clock signal is below -0.5V within a single clock period. The undershoot threshold duration must not exceed 20% of the period.
