Intel386™ EX Embedded Processor

Specification Update

August 2004

Order Number: 272873-011

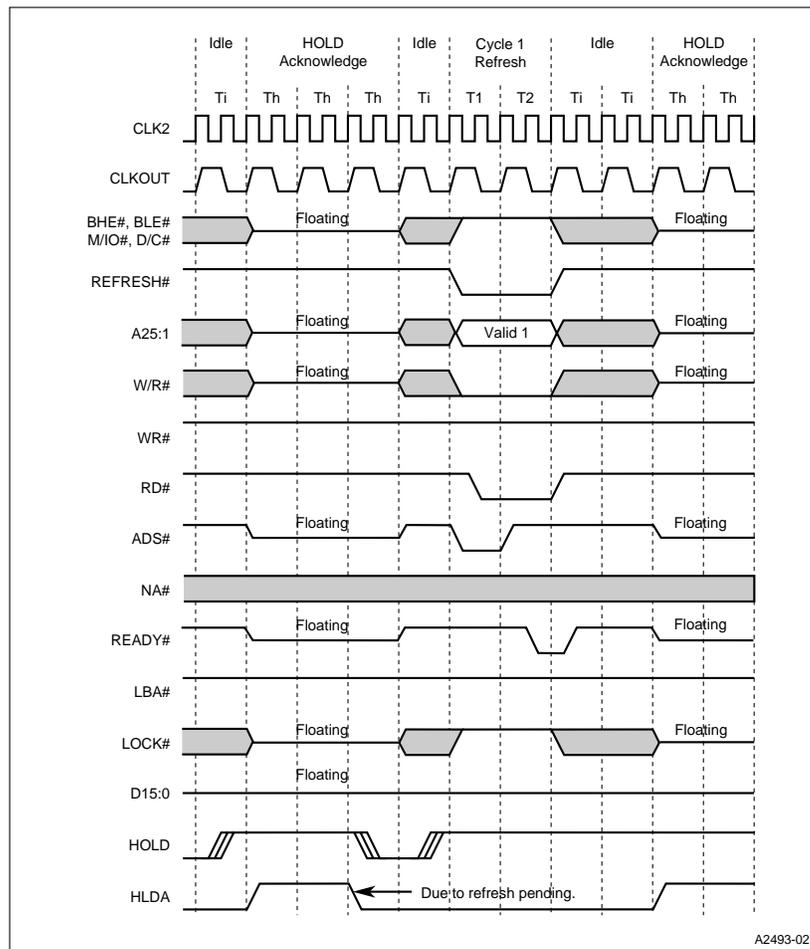
11. 272485-002, Section 6.3.6, Page 6-30, Figure 6-12.

Issue: Modified the ADS# and READY# waveforms to indicate floating. The corrected figure is shown below.

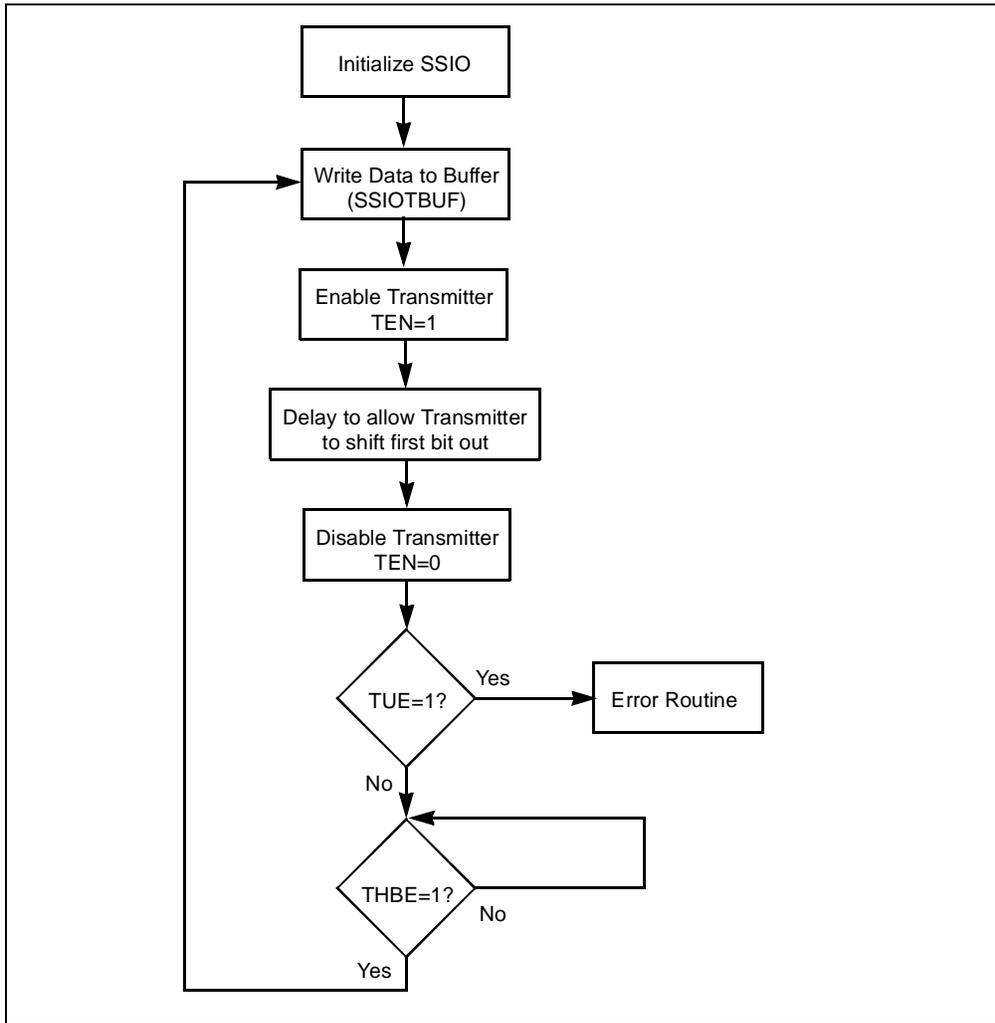
Figure 12. Transmit Data by Polling

Issue: Replace figure 13-8 with Figures 13-8a and 13-8b as shown below.
