# **80C186EA/80C188EA AND 80L186EA/80L188EA EMBEDDED MICROPROCESSORS SPECIFICATION UPDATE**

Release Date: August, 1997

Order Number: 272896-003

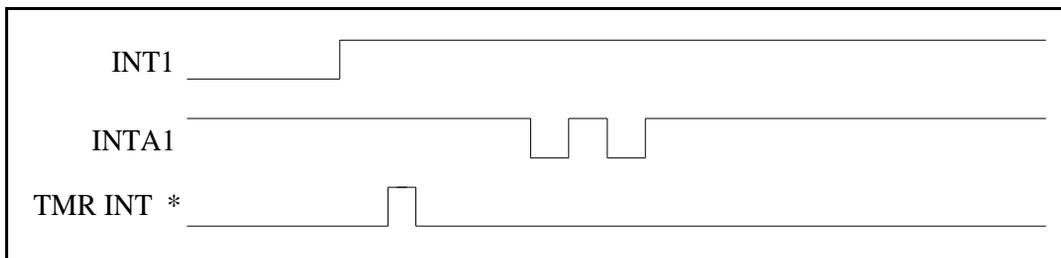
Correct operation of the device acknowledges the interrupt on INTA1# after an interrupt on INT1. Normally, this occurs even if there is a higher priority interrupt after INT1 but before the acknowledge (Figure 1).

**Figure 1. Correct INT1 Acknowledge Sequence with Higher Priority Timer Interrupt**

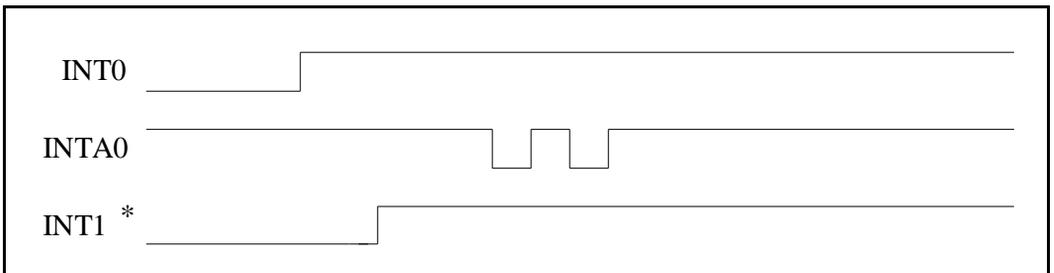
Correct operation acknowledges INT0 on INTA0#. Normally, this occurs even if there is a higher priority INT1 after INT0 but before the acknowledge (Figure 4).

**Figure 4. Correct INT0 Acknowledge Operation with a Simultaneous INT1**

\*Note: INT1 is the only interrupt that causes the errata to occur.
