This document covers all aspects of computer clock/CMOS RAM device replacement for manufacturers including Dallas Semiconductor, Odin, Benchmarq, Twinhead, Thomsen-Mostek and Houston Tech.

**How do I recognize Dallas Semiconductor modules on my system board?**

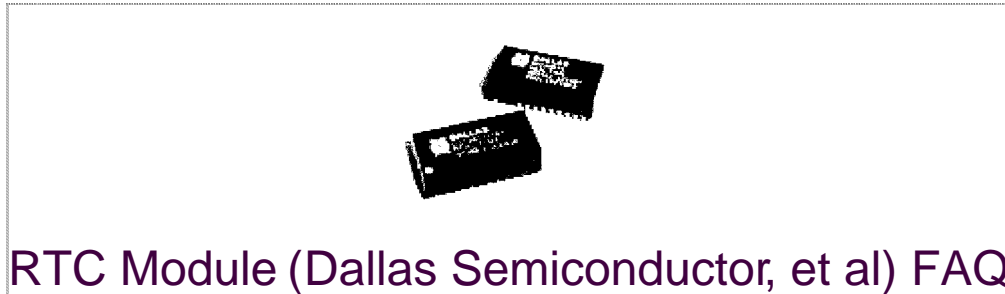
Dallas Semiconductor "Smart Batteries" and computer clock Modules with on-board batteries are easy to identify.\* The most commonly used types are:

- DS1260
- DS1287
- DS12887
- DS12887A

Dallas Semiconductor modules are distinctively marked with an alarm clock like the ones shown above.
