Pentium® Processor Specification Update

Release Date: March 1998

Order Number: 242480-035

The Pentium® processor may contain design defects or errors known as errata which may cause the product to deviate from published specifications. Current characterized errata are documented in this Specification Update.

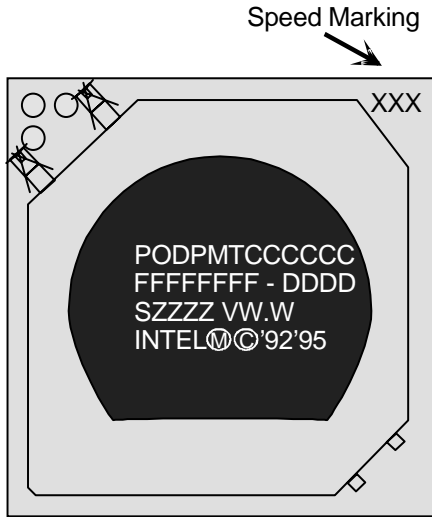
125/150/166/180- and 200-MHz Pentium®
OverDrive® Processors with MMX™ Technology

The Pentium OverDrive processor can be identified by the number on the base of the heat sink, under the integrated fan. To remove the fan, squeeze the retaining clips in the upper left corner of the chip and lift up. The figure below shows the laser mark found on the heatsink base of the processor. A marking is also used to indicate the speed of the part and is located in the upper right of the package.

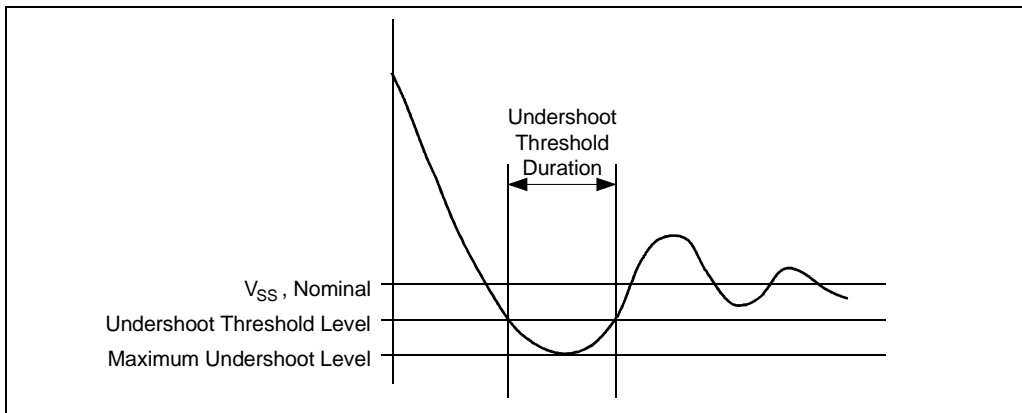
Figure14-1. Maximum Undershoot Level, Undershoot Threshold Level, and Undershoot Threshold Duration

MAXIMUM RINGBACK SPECIFICATION: The maximum ringback of CLK associated with its low state (undershoot) must not exceed 0.8V as shown in Figure 14-1.

UNDERSHOOT THRESHOLD DURATION SPECIFICATION: A snapshot of the clock signal should be taken at 500 mV/div and 500 pS/div (for CLK). Adjust the vertical position and horizontal offset position to view the threshold duration. The undershoot threshold duration is defined as the sum of all time during which the clock signal is below -0.5V within a single clock period. The undershoot threshold duration must not exceed 20% of the period.

This undershoot specifications are illustrated graphically in Figure 14-1 and Figure 14-2.

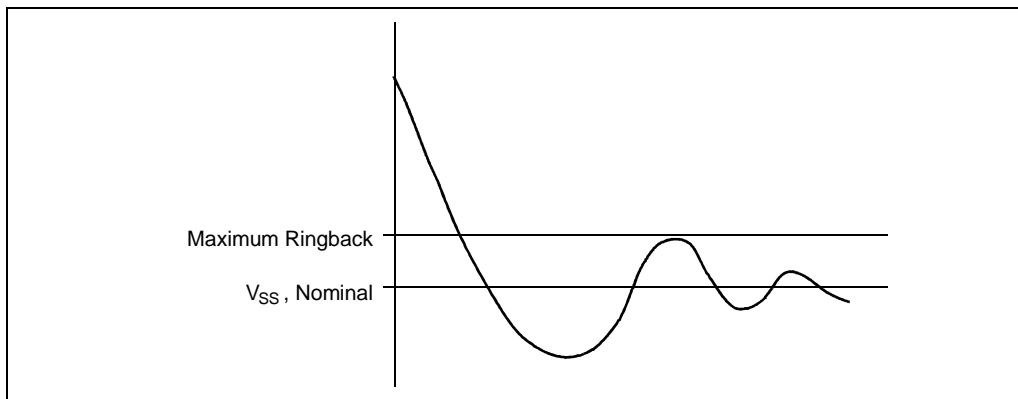
Figure 14-2. Maximum Ringback Associated with the Signal Low State
